Manhole Inspection Summary

Manhole # S67I__004MH

Location Address: **600 Dundalk Ave.**

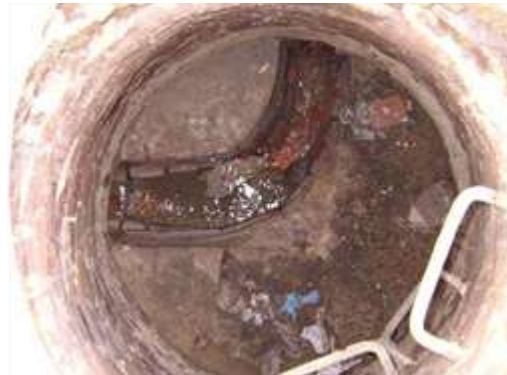
Top View

Comments **MH HAS STORM DRAIN MH COVER**

Frame Offset: **4** (in.) Condition: ☐ Sound ☐ Cracked ☒ **Leaks**

Condition: ☐ Sound ☒ **Cracked** ☐ Root Intrusion ☒ **Loose Brick** ☒ **Deteriorated**

Infiltration: ☐ None ☒ **Joint** ☐ Cracks ☒ **Mortar** ☐ Roots ☐ Wall
